# Preprint 14-137

## VENTILATION IMPROVEMENT IN LONGWALL RECOVERY FACE USING CONVERGENCE TRANSDUCERS - CASE STUDY

A. Habibi, FMC Corp., Green River, WY  
R. Kramer, FMC Corp., Green River, WY  
S. Gillies, Missouri Univ. of Science and Tech., Rolla, MO

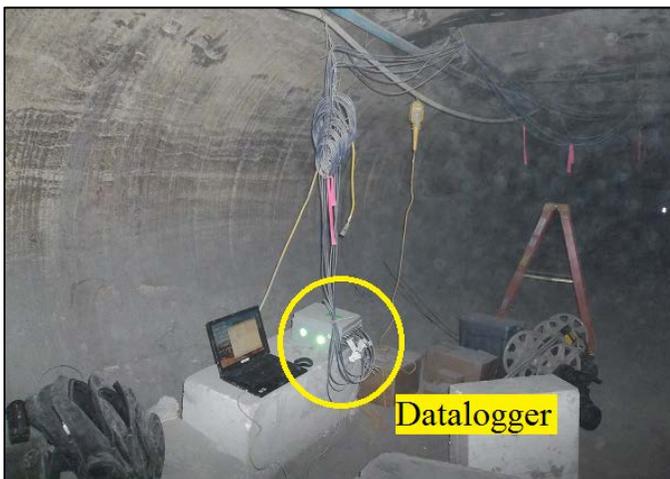
Figure 5. Monitoring base located at 1<sup>st</sup> access chute.

A MSHA approved, permissible, handheld unit was used to read transducers once the LW face broke through into the recovery room at the tailgate. Data was collected as the remaining fender pillar was mined and the LW completed entry into the room. The datalogger was replaced since it didn't meet the permissibility requirements for the gassy environment. Readings were taken manually with the application of a terminal box switching from meter to meter using the selectors on the box. A software solution provided by the manufacture was used to input the calibration equations for each transducer.

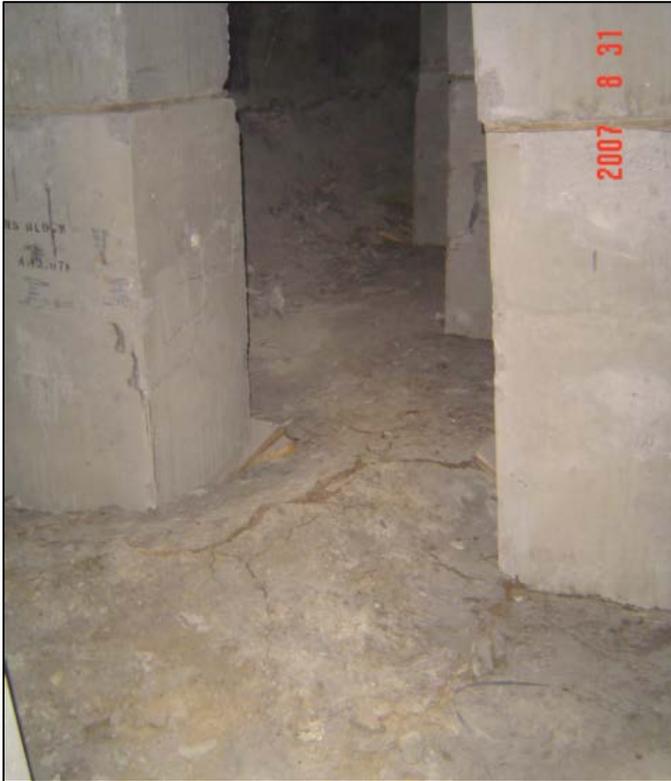
The crib monitoring results show 210 crib sets out of 494 sets were cracked or failed during the entry process. The cribs were set in four rows along in the Recovery Face. The crib density increases to five rows from third access chute to the tailgate. The results also show that no activity was observed among the crib sets from zero room to the belt drift. Figure 7 shows the cracks on the floor.

**Figure 7.** Excessive floor heave and cracks on the floor.

The floor heave was monitored along the recovery room face. As the floor heaved the cribs took the load. The plastic floor material then heaved around the base of each crib. The floor heave in between the rows was also observed. The cracks were observed in the tailgate area when the LW was still 4m away from entering the tailgate side of the recovery room.

- It was observed that excessive floor heave can lead to creation of cracks in the floor. This significantly increased the gas concentration to 0.95%. The correlation of floor heave and methane liberation vs LW face location was analyzed. The observations show that gas liberation started when LW face was approximately 10m out which may have a direct relation to floor heave.

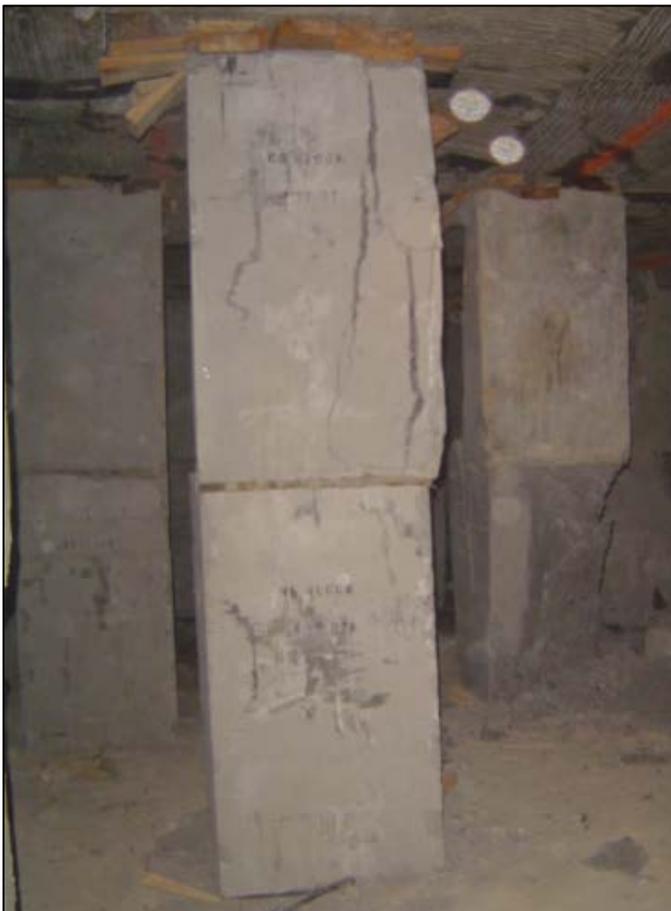
The D crib row (inby and closest to the face) was the most active row. The mid face cribs in all the rows also took significant amount of load. Figure 8 shows a failed concrete block. It was also observed that the top concrete block tends to fail.

**Figure 8.** Failed crib at the Recovery Face.

- It was observed that the top concrete block on each crib set tended to fail or crack. Most of the cribs that failed were located from tailgate to mid panel. This is perhaps a result of increased loads due to proximity of previous panels located on the tailgate side of current panel.
